RARITAN RIVER BASIN
BIG BEAR BROOK, MERCER COUNTY
NEW JERSEY

GROVER'S MILL DAM

NJ 00155

PHASE 1 INSPECTION REPORT
NATIONAL DAM SAFETY PROGRAM

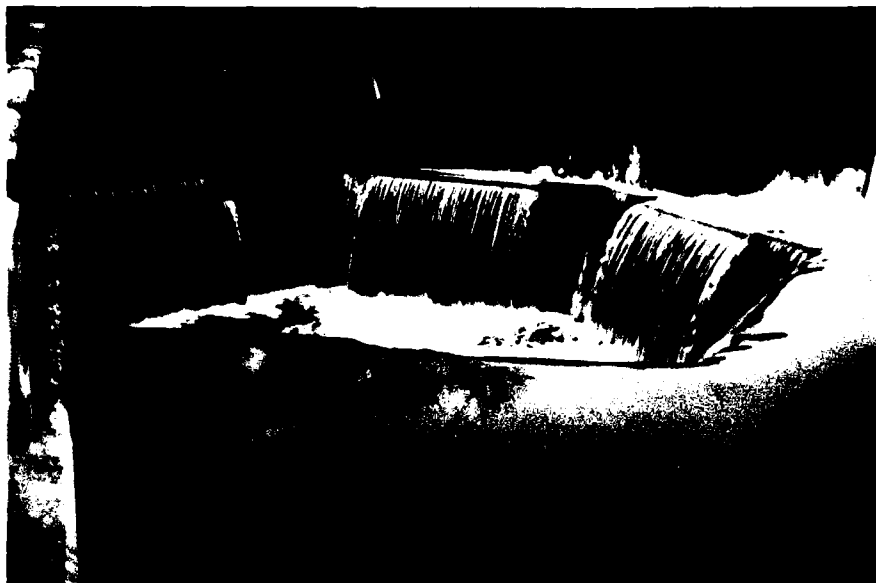
The concrete forming the horseshoe spillway appeared to be structurally sound although some erosion was observed at the crest resulting in exposed aggregate. The weir portion of the spillway was partially obscured by overflow at the time of the inspection.

12 NOVEMBER 1979
PHOTO 1
SPILLWAY

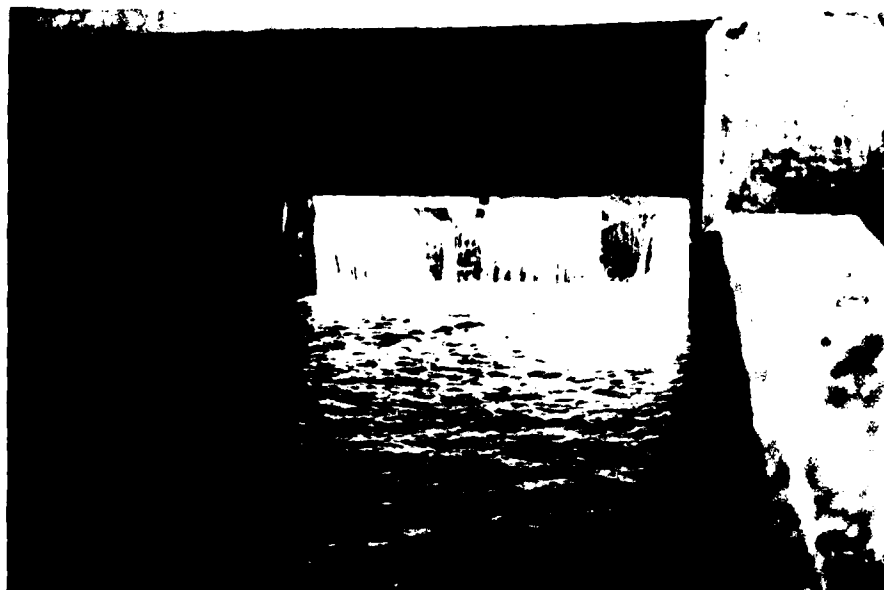
PHOTO 5

The bridge is Mercer County Bridge No. 762.2 built in 1931. The condition of the concrete comprising the bridge and discharge channel under the bridge appeared to be in fair condition. The concrete surfaces exhibited moderate deterioration with some cracks, spalls and leaching noted. The downstream wingwalls appeared to be in poor condition. The surfaces were generally sound with cracking and severe spalling at the downstream ends. The concrete wall adjacent to the right wingwall was tilted in the downstream direction.

SPILLWAY DISCHARGE CHANNEL FORMED BY BRIDGE ABUTMENTS
